TEST REPORT

No. : XMIN1804002487ML

Sample Name : SOLAR MOUNTING SYSTEM

Material and Mark : AL6005-T5

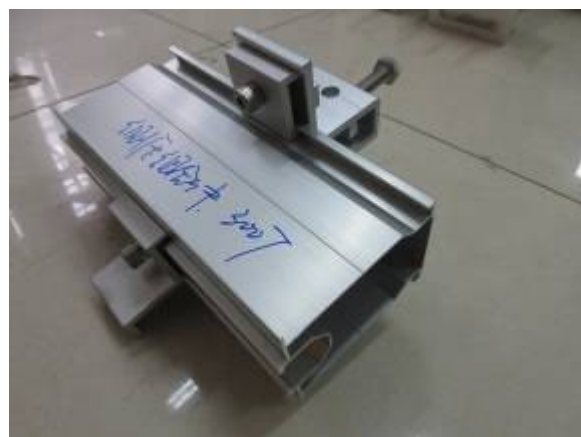
Photo 1: End clamp

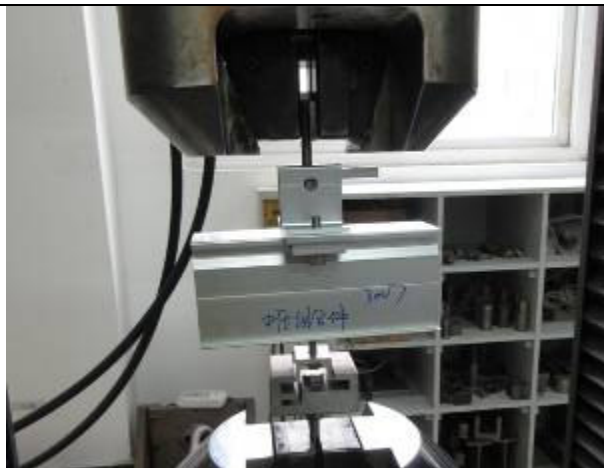
Test method: according to the client's requirement, fixed the sample on the test machine, the M8 bolts fasten by 12N.m torque, the M10 bolts fasten by 24N.m torque. Loading the force as a speed of 3mm/min till destroyed. Record the maximum force and the displacement under maximum force.

Photo 2: During the test

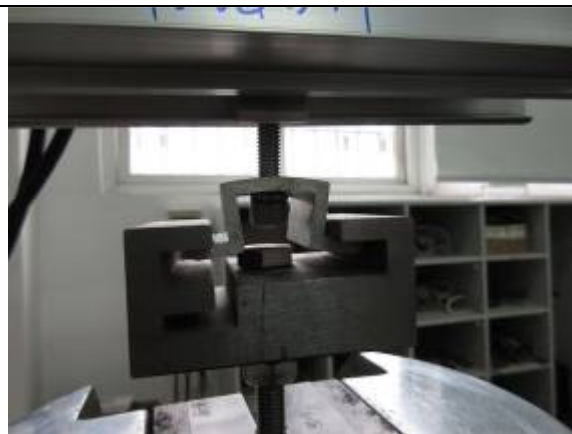
No.	Sample name	Maximum force (kN)	Displacement under maximum force (mm)	Destroyed location
1#	End clamp	7.09	10.29	See photo3 and photo 4
2#	Middle clamp	6.89	7.93	See photo7 and photo 8
3#	Beam 1	10.46	9.18	See photo11
4#	Beam 2	9.52	11.19	See photo14

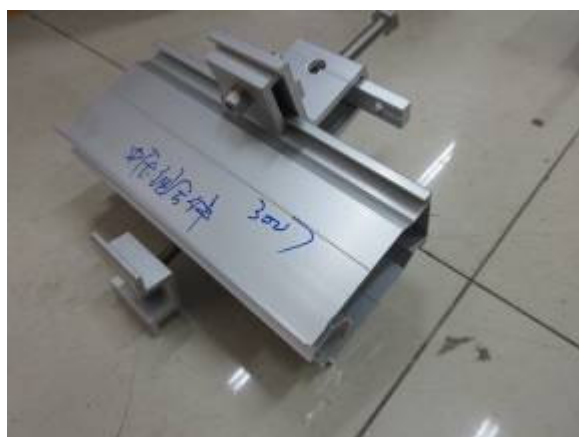
Photo 5: Middle clamp

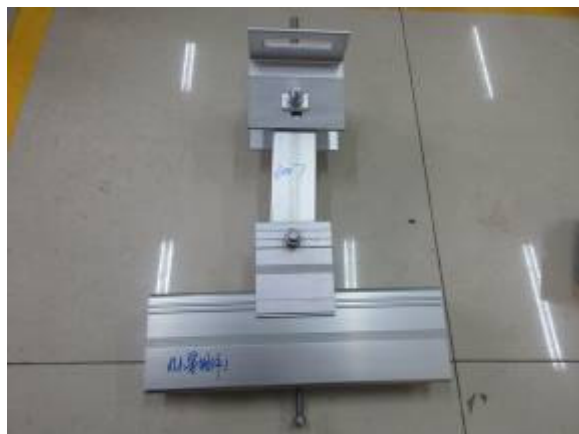
Photo 9: Beam 1

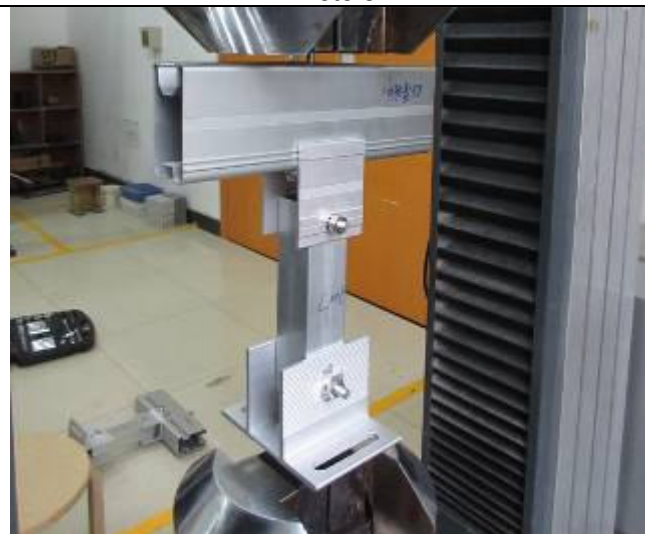
Photo 10: during the test

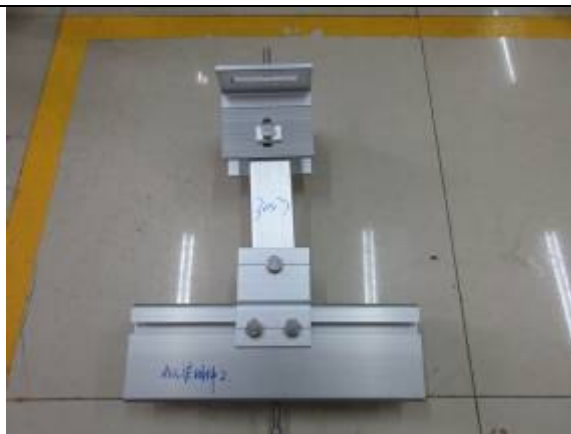
Photo 12: Beam 2

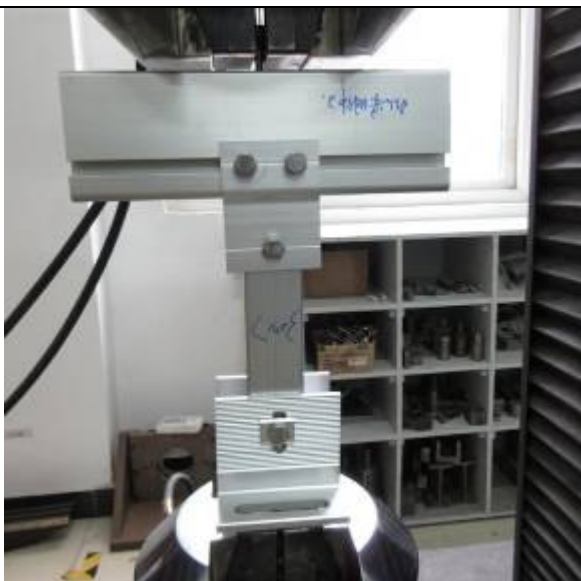
Photo 13: during the test
